# *Common Area Infrastructure Assessment*

## *Hickory Woods, Londonderry*

August 15, 2017

CLD Ref. No. 17-0224

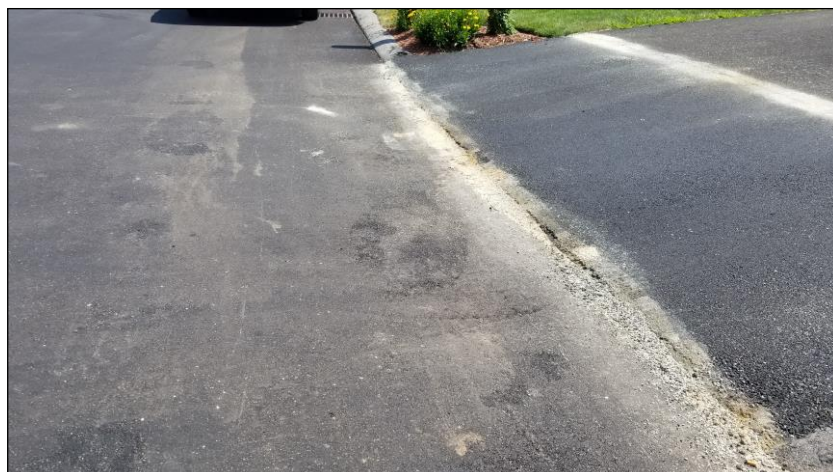
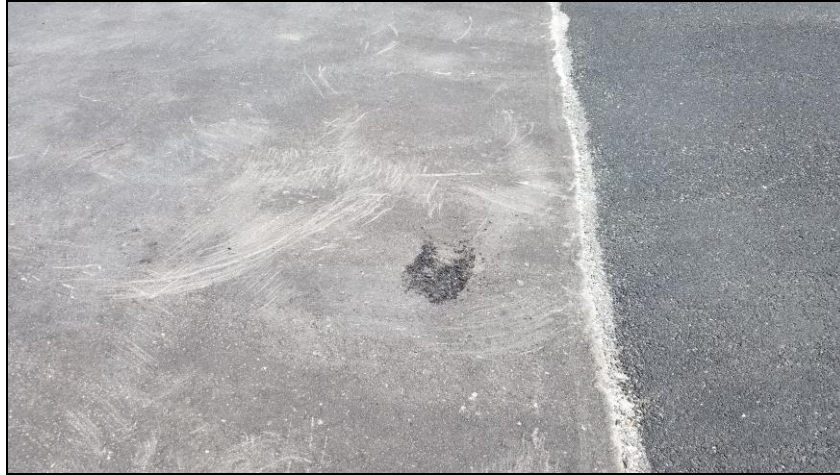
Some of the driveways have been constructed without removing or lowering the curb. Scrapes on some of the driveways indicate that this was causing vehicles to bottom out. It was observed that some of the driveways have been corrected, and some more driveways were in the process of being repaired during the site visit. The repairs were made by saw cutting the driveways approximately 5' from the curb line and repaving the last section driveway. These repairs should correct the concern; however an additional joint is created. These additional joints should be crack sealed to prevent failure at these joints.

It was also observed that these repairs were done approximately 5 weeks after the top coat of pavement was laid. Due to the heat of the summer the pavement is still somewhat soft and some scuffing and minor damage has occurred in the street adjacent to these driveways. Most of this is cosmetic, but it appears as if in some areas, small gouges were filled with asphalt. These gouges are likely to be the first to fail and create potholes in the future if not maintained.

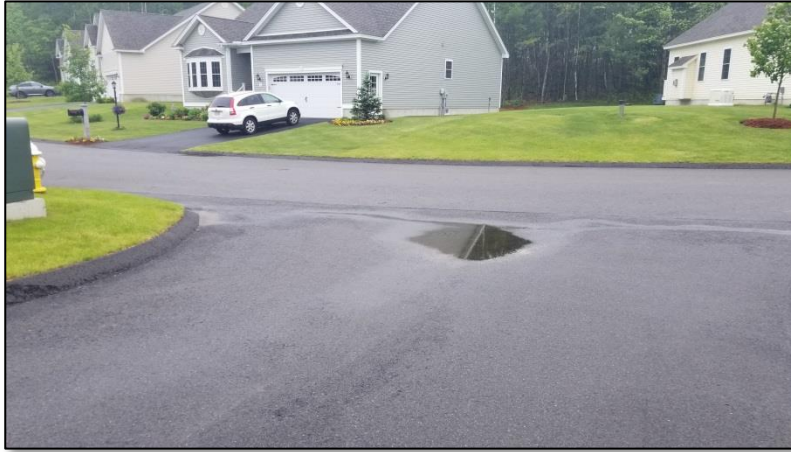
We observed a puddle at the entrance of the Clubhouse parking lot off of Tavern Hill Road. It's unclear if this is from settlement or from improper construction. This puddle will freeze and cause ice and potentially cause an accident.

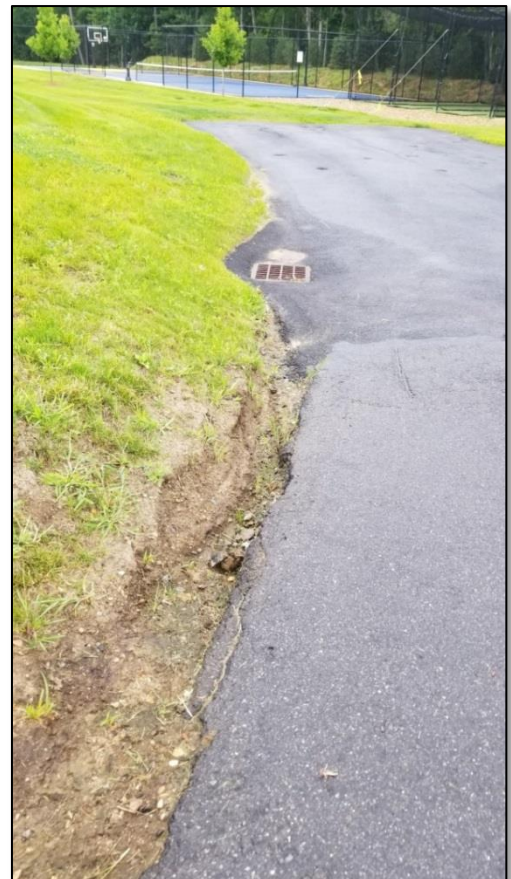
### 2. Church Lane Erosion:

The north side of Church lane is eroding due to stormwater runoff & a lack of curbing or swale in this location. The edge of the pavement is starting to receive damage and sediment is being washed to the catch basin and rain garden. This swale should be stabilized as soon as possible to prevent damage to the pavement. Many methods are possible, but cutting in a small swale is recommended, with either loam, seed, and jute matting, or small riprap underlaid with filter fabric would also likely work.

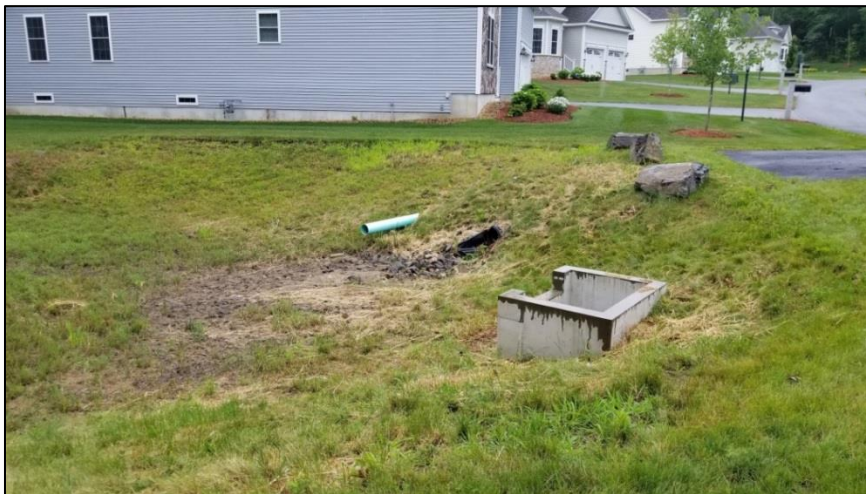
### 3. Rain Garden #1: (End of Church Lane)

There are multiple deficiencies observed with Rain Garden 1 including the following:

- The outlet structure is missing its grate. This should be installed immediately.
- The PVC inlet pipe extends too far into the pond. This pipe should be cut back with a flared end section or at minimum riprap stabilization.
- There is sediment accumulated in the pond
- Where the edge of the sod from the neighbor's house meets the top of the pond is an abrupt drop-off which will likely erode in the future and be difficult to mow. We recommend blending the transition better.
- The back of the pond (opposite the outlet structure) is steeper than planned. It's unclear if this is due to ledge or a large boulder. This may be a cause for concern as the grass is slightly thinner than the rest of the area.
- The design plans call for a rain garden planted with shrubs and a mulch bottom. This appears to have been constructed as a typical detention pond.

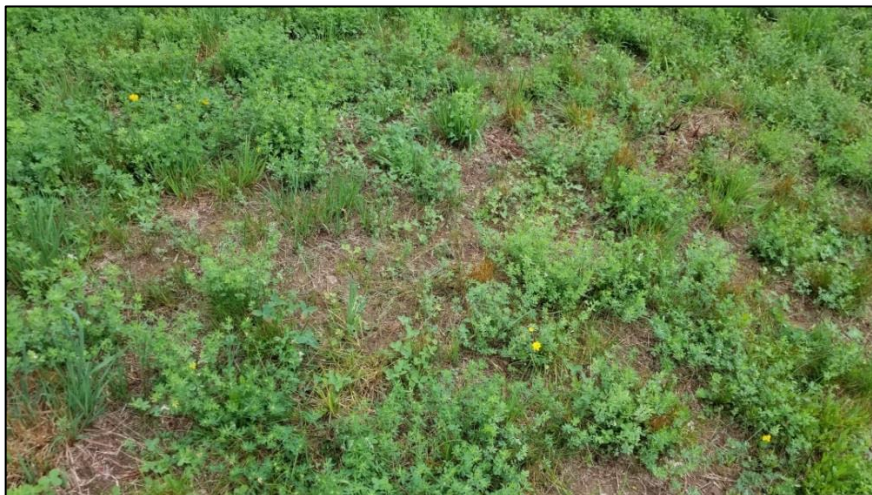
### 4. Detention Pond 1NE

The detention pond appears overall in good shape and functioning well. Some of the grass around the outlet side is fairly thin. Additional grass seed may be planted to provide a denser vegetated cover to protect this from eroding.

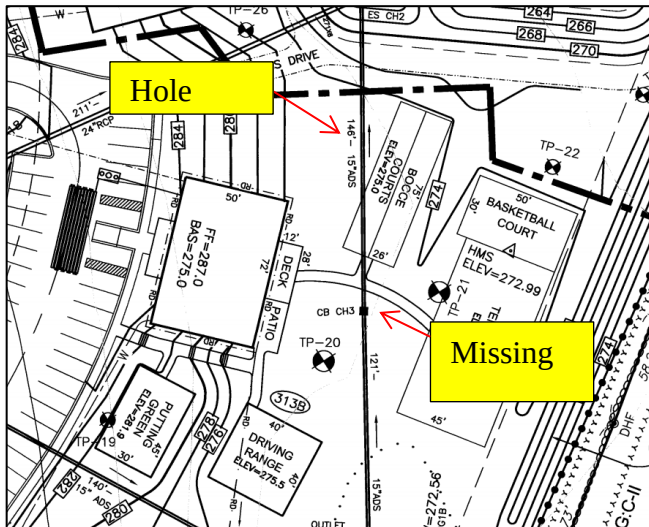
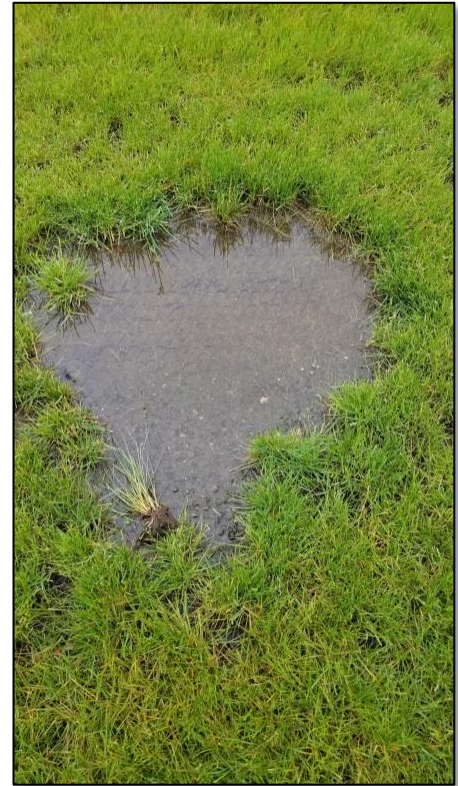
## 5. Missing Catch Basin

The design plans call for a catch basin to be located behind the clubhouse. This catch basin appears to not have been installed and the area behind the clubhouse is soggy and does not drain during rain events. It's unclear why this catch basin was not installed. There is also a hole in the lawn that accumulates water

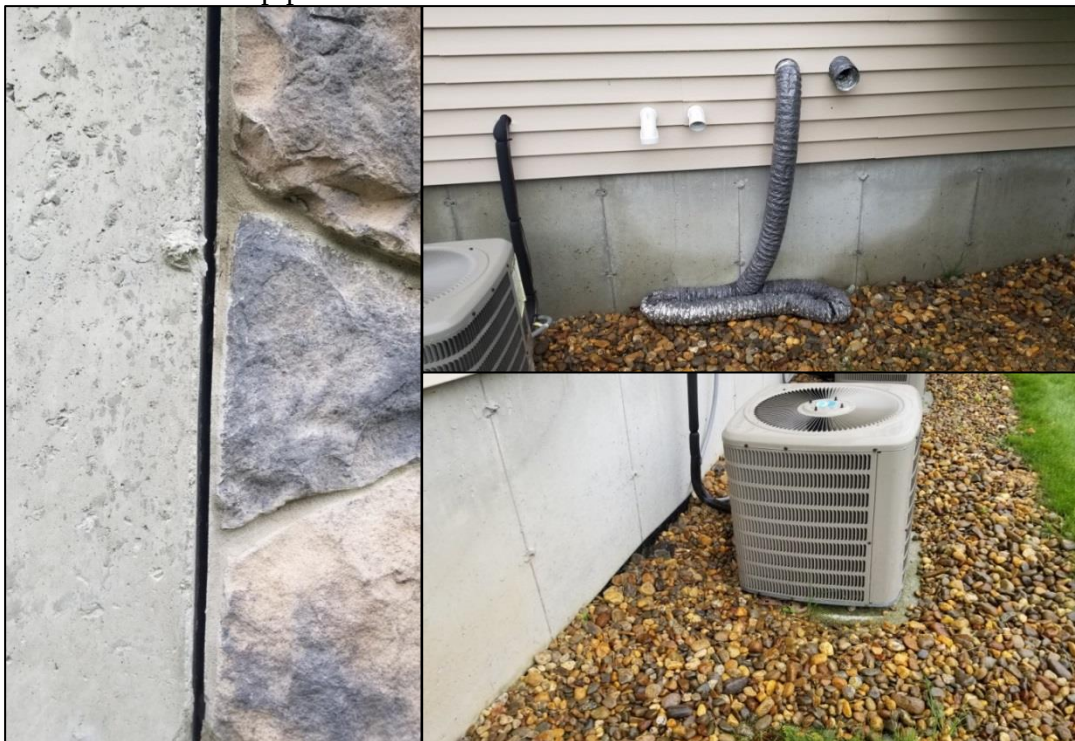
## 6. Clubhouse Exterior:

There are three noted deficiencies on the exterior of the clubhouse.

1. The retaining wall on the north side is separating slightly from the foundation and may cause sediment transport.
2. The air conditioning unit is sinking
3. There is a vent pipe that is disconnected and is tattered.

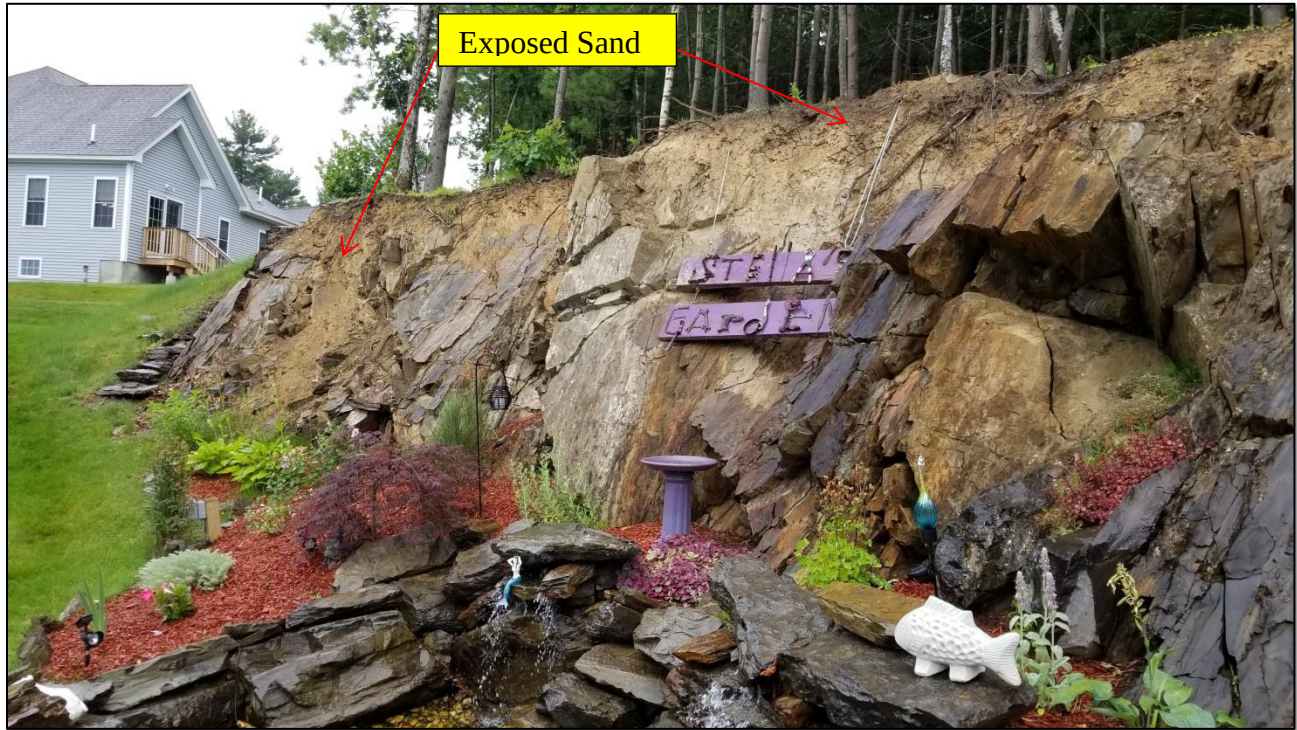
**7. Ledge Erosion behind unit 32**

There is an area behind unit 32 (31 Black Forest Circle) that was blasted/hammered and is exposed ledge. While the ledge itself appears stable, there is exposed sand above the ledge and to the side of it that does not appear stable. This could potentially cause the trees above the ledge to fall down onto the house. The exposed sand should be stabilized somehow to prevent additional erosion and trees from falling onto the house. It is recommended that a geotechnical engineer inspect and provide recommendations.

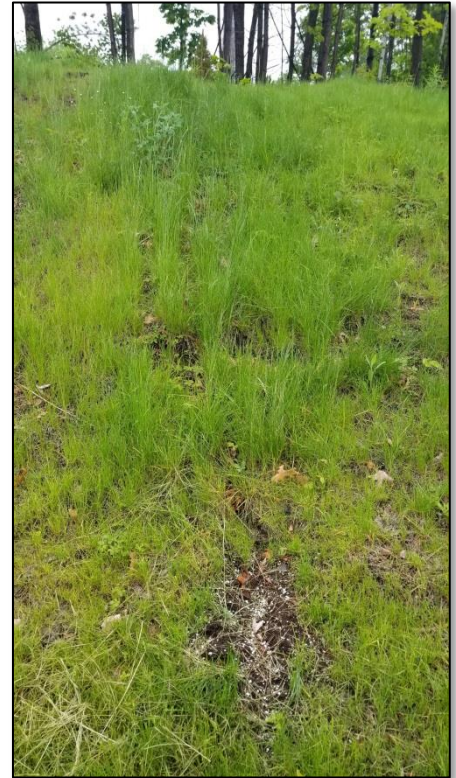
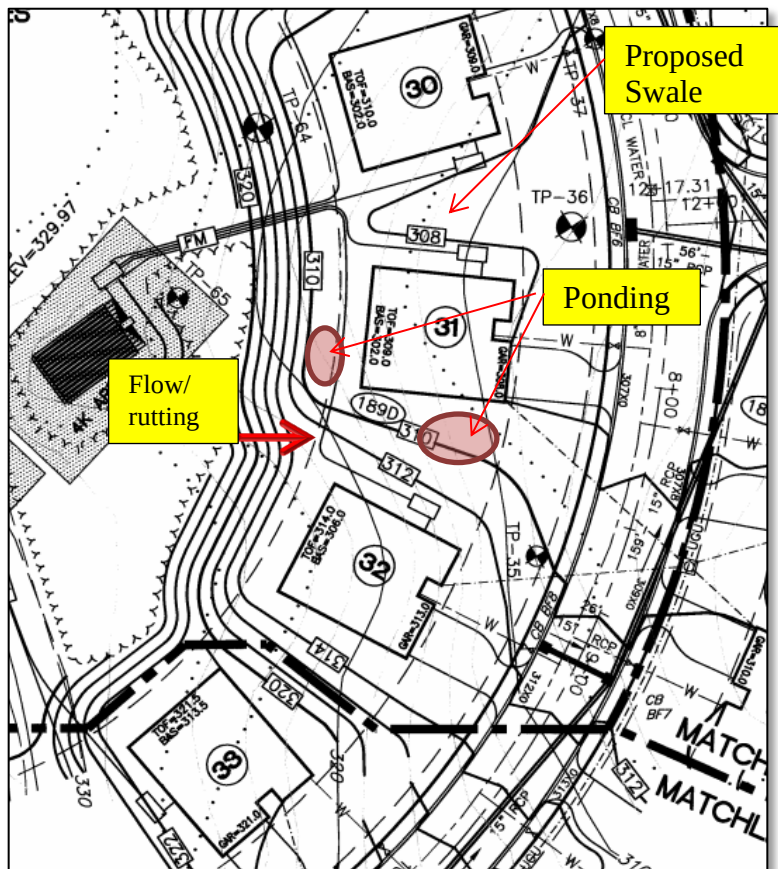
**8. Drainage behind unit 31/32 (#33 Black Forest Circle)**

The stormwater from the cell phone tower area all flows directly to the backyard behind #33 Black Forest Circle (Unit 31). This stormwater is causing some rilling in the slope and is causing some ponding in the backyard and then it flows between units 31 and 32. The slope between unit 31 and 32 is very flat which is also causing some ponding between the two homes. The design intent was for this stormwater to flow between units 30 and 31 where a swale could collect it and route it to the catch basin in the street.

Diversion methods should be explored or perhaps infiltrating the stormwater before it makes it down the banking would be an alternative. We suggest that the design engineer be involved in proposing solutions. It was also observed that the swale between 30 and 31 was not constructed per the design plans and is also ponding between the homes. The concern with ponding between and around the homes is that the basements could flood. A potential alternative is to provide yard drains to connect to the catch basin in the street

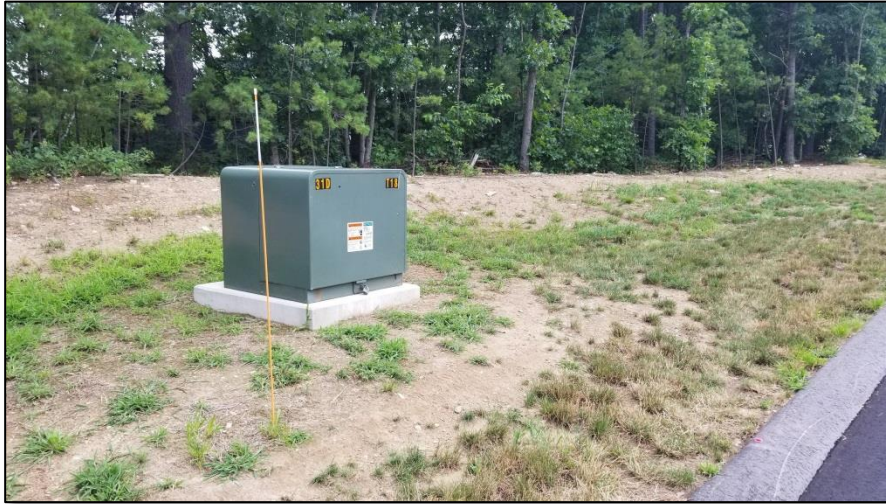
**9. Tree Buffer along Quarry Road:**

The plans indicate that at least 10 trees to supplement the buffer should be added. There are only 3 trees provided and noticeable gaps where the additional trees would help supplement the buffer to the abutting property.

The area is also unstable, both along the treeline and around the transformer. Loam and hydroseed should be added to stabilize the area.

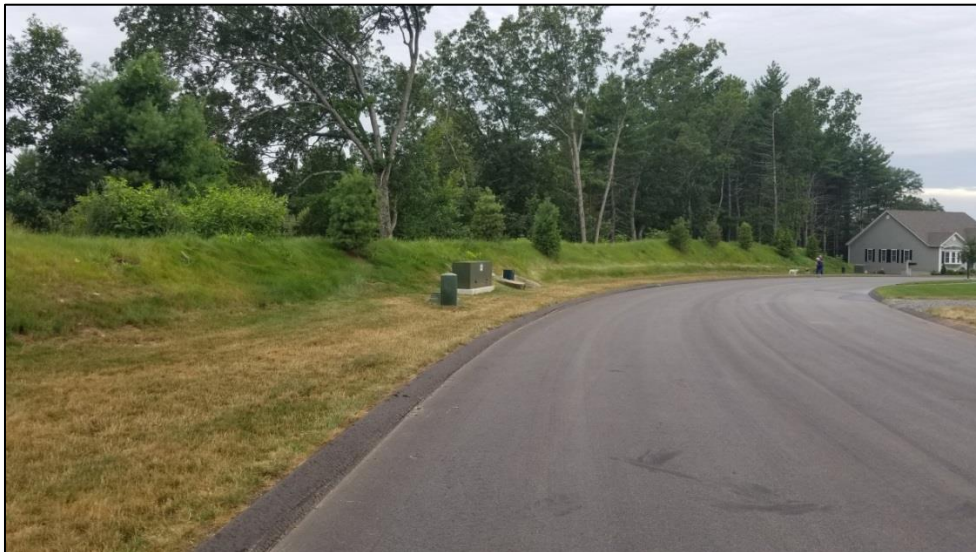
**10. Tree Buffer along Black Forest Road:**

The plans indicate that 25 evergreen trees should be planted along the berm. Only 9 trees were observed in the field, with holes where some of the dead trees have been removed. The trees should be replanted with temporary or permanent irrigation to ensure they survive.

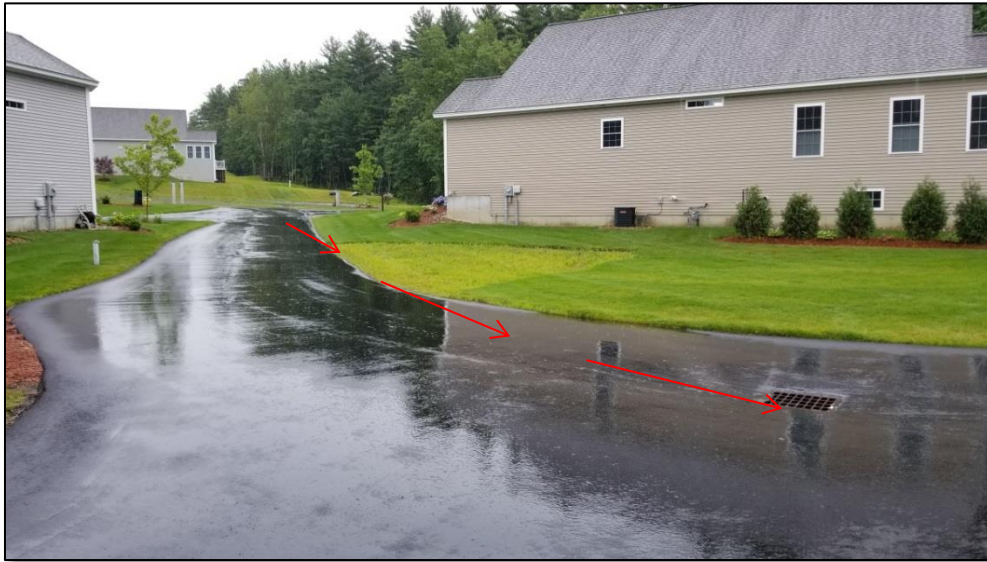
**11. Catch Basin at Pepper Mill Cul-De-Sac**

The catch basin at the end of the cul-de-sac appears to have been designed to take the roadway flow. The road and cul-de-sac appears to have been constructed differently than planned which causes the runoff to head down the shared driveway to the catch basin in the pavement. The drainage seems to be working fine, but the concern is in the winter that this long flow

path may cause icy conditions. The steepness of the driveway may allow it to drain properly however. The runoff also flows alongside the driveway for part of the driveway, which in the future may cause erosion. The area should be reviewed in the winter for icing concerns and reviewed periodically to ensure erosion isn't occurring at the edge.

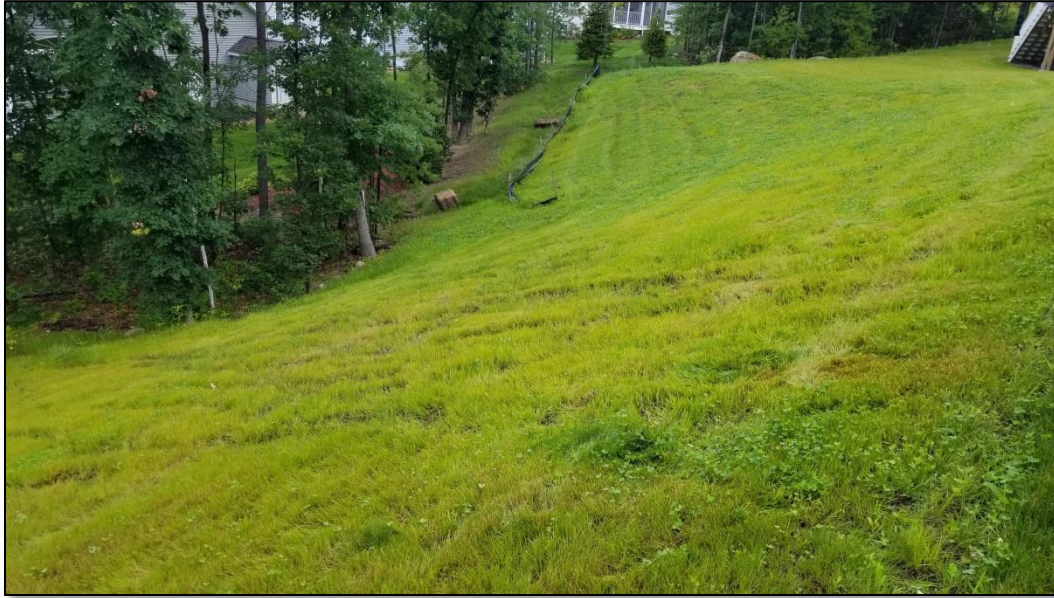
## 12. Slope behind Unit 59

The slope behind unit 59 is fairly steep and fairly long. During our second visit we observed some minor rilling in the slope. On a follow up visit on July 26 the rills have partially stabilized, however the rills should have a bit more seed added and perhaps a short section of straw wattle to ensure the rills become fully stabile.

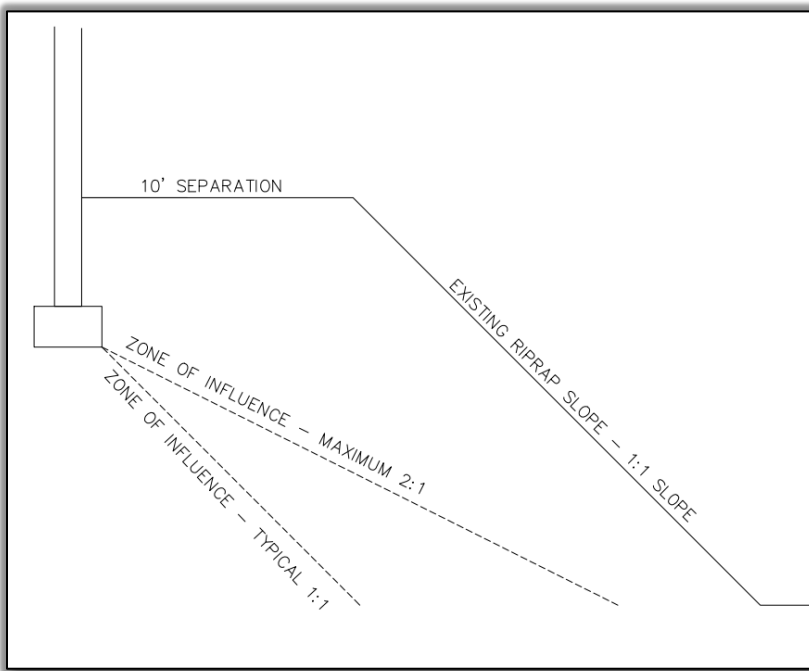
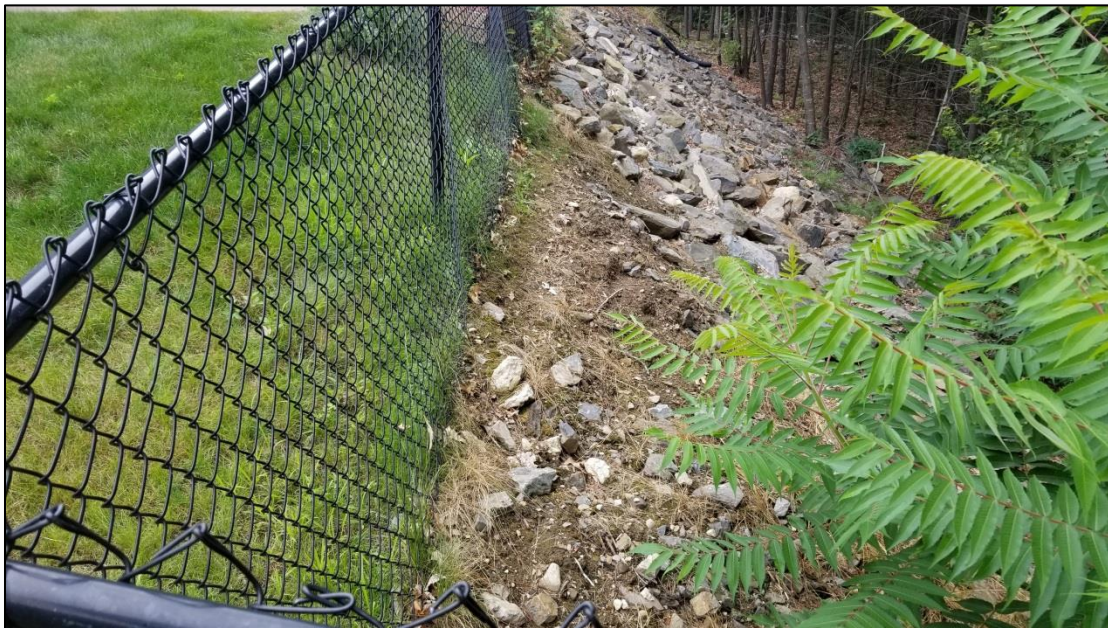
## 13. Riprap Slope behind units 16-19

We were asked to review the riprap slope behind units 16-19 (4 – 10 Black Forest Circle) to review the proximity of the homes to the steep slope and the condition of the slope. A detail was not found for the slope so we don't know if this was engineered or constructed by the contractor without design. Typically slopes as steep as this should be designed by a geotechnical engineer, and at a minimum under laid with a filter fabric, laid with thick layer of riprap (typically 8-12" +), with benching constructed mid slope. The slope appears to be constructed from mostly variable diameter riprap but it wasn't obvious if it was underlaid with fabric. Overall the slope appears to be mostly stable except for a portion where a foundation/roof drain outlets at the top of the slope behind 6 Black Forest Circle. There is minor erosion around the outlet which should be stabilized to prevent undermining and additional erosion and an area that needs a bit more stabilization. It was also noted that a planter at the top of the slope appears to have shifted/sunk after its installation. Since the slope doesn't appear to be engineered, the slope should be visually monitored for stability on a somewhat regular basis. It is recommended that the developer have a geotechnical engineer review the stability of the slope and offer assurance that the slope was properly constructed and will be stabile in the long term.

The closest house sits approximately 10 feet from the top of the slope. The riprap is a 1:1 slope. The zone of influence of the house is typically a 1:1 slope but can max out at 2:1. Based on the proximity of the slope to the house we do not anticipate the house footings having an influence on the slope, so provided this slope remains stable it should not cause danger to the homes.

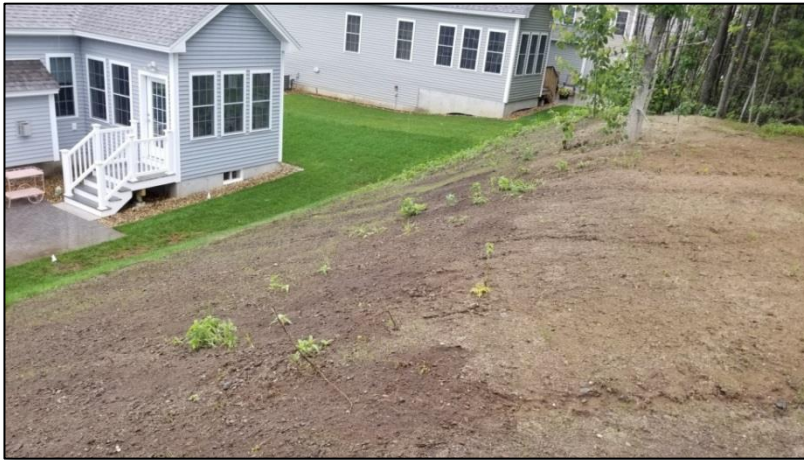
#### 14. Septic/Slope behind units 77 & 78

We also performed two auger holes to review any issue with the septic system. The first was in the sand at the edge of the leach field. The sand appeared dry and to meet the system sand specifications. The second auger was mid slope to look for seepage from the leach field. No seepage or signs of failure were observed. There was some dead grass noted at the bottom of the slope. This appears to be caused by sediment washing down the slope.

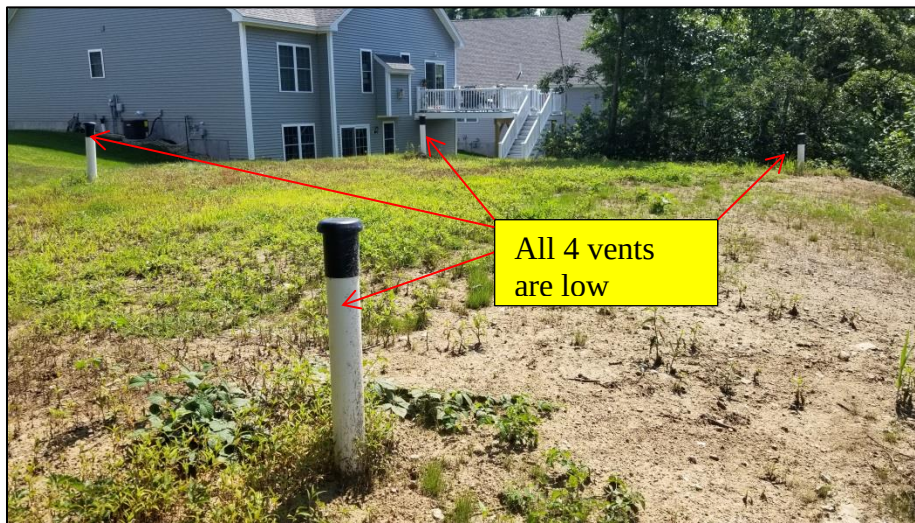
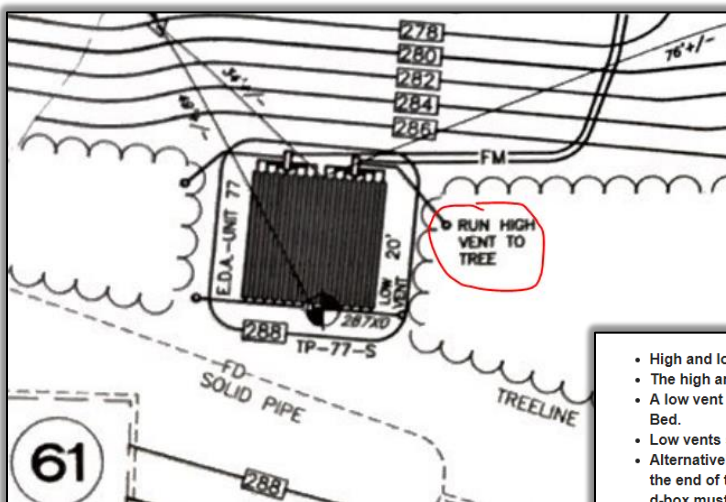
One noted deficiency is that the pumped leach fields were supposed to have a high vent off of the D-Box and a low vent off of the end of the leach field. In the field it was observed that there were 4 low vents. The high vents (off of the D-box) should be 10' higher than the low vent to allow for proper air circulation. This will cause the system to fail if not corrected. While most of the remaining septic systems were not inspected, the high vent/low vent differential should be completed at all pumped systems. Gravity systems only need the low vent as the high vent is run through the house.

- High and low vent openings must be separated by a minimum of 10 vertical feet.
- The high and low vents should be of the same capacity.
- A low vent is installed through an offset adapter at the end of each row, Section or Basic Serial Bed.
- Low vents should be a minimum of 3 ft. high or above snow line.
- Alternatively, the low vent may be attached to the d-box and the high vent may be attached to the end of the last AES or Enviro-Septic® row. If this configuration is used in cold climates, the d-box must be insulated to prevent it from freezing.
- A high vent is installed through an unused d-box outlet (see diagram below).
- Sch. 40 PVC or equivalent should be used for all high vents.
- All high vents should be at least 4 in. in diameter.
- All vents higher than 3' should be anchored.

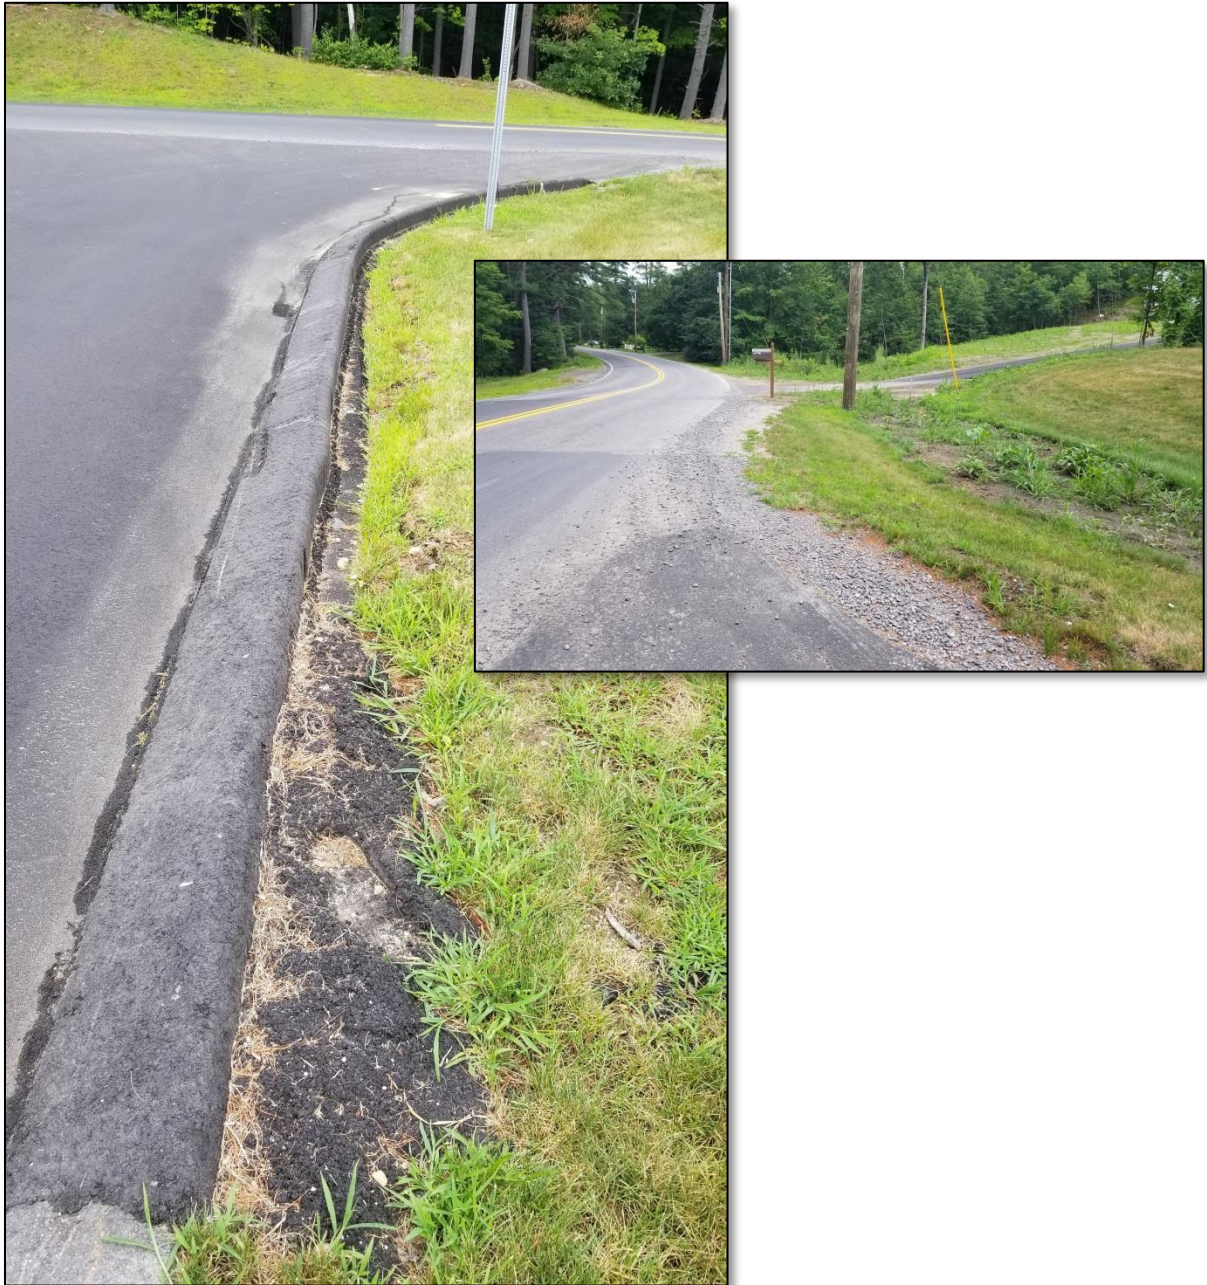
The curbing at the exit to West Road needs loam and seed behind it to complete the stabilization. The shoulder on West Road and the grass beyond the shoulder need to be cleaned up and stabilized.

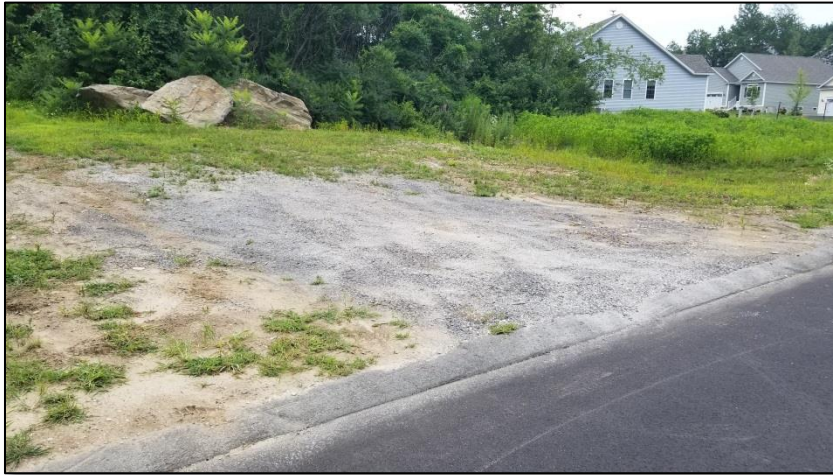
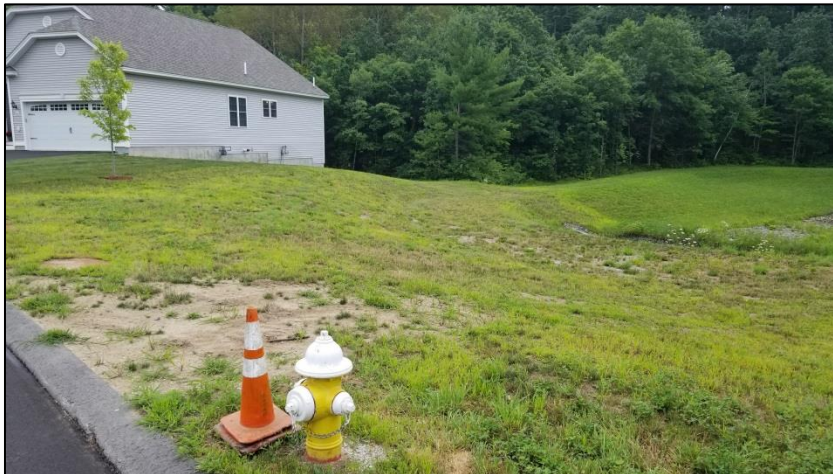
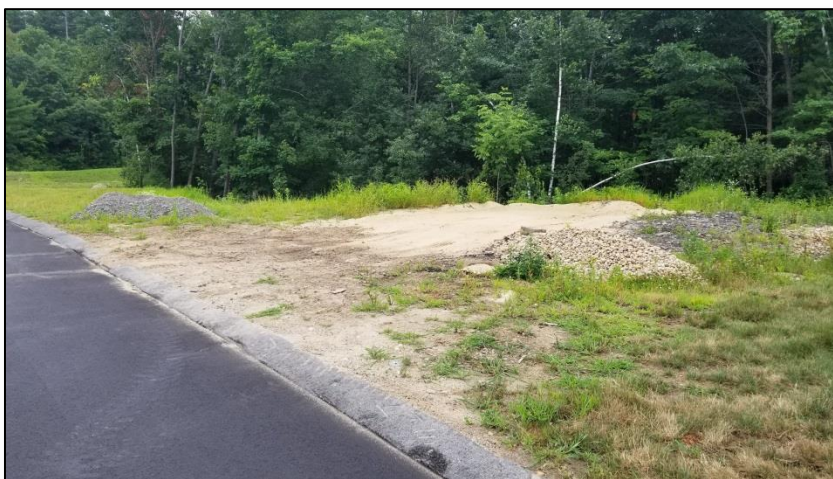
**16. Debris at staging area**

There is some construction debris remaining and two staging areas near lot 83 (37 Quarry Road) that should be removed and vegetated. The shoulder next to the detention pond also needs to be stabilized.

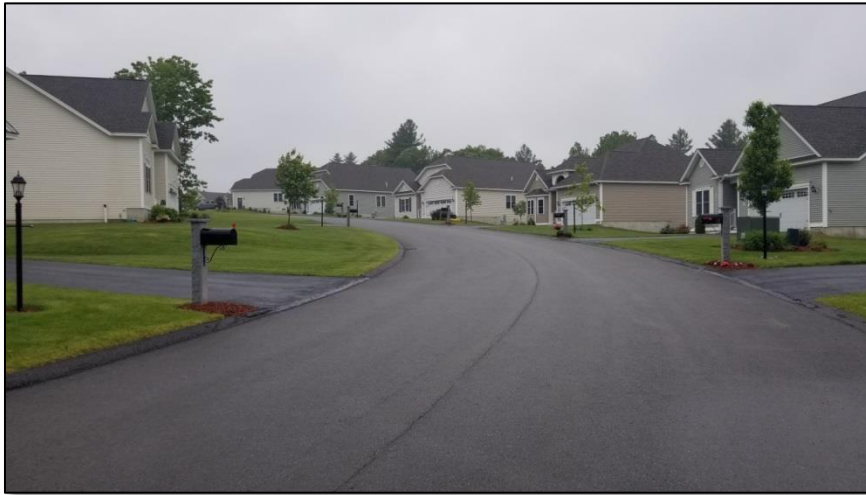
### 17. Cracking Tavern Hill Road

A fairly large crack was observed the entire length of Tavern Hill Road. This may have been caused by construction traffic or just normal wear. The crack is small enough to fill with crack sealant, but should be done as soon as possible and monitored and filled in as necessary to avoid premature roadway failure.

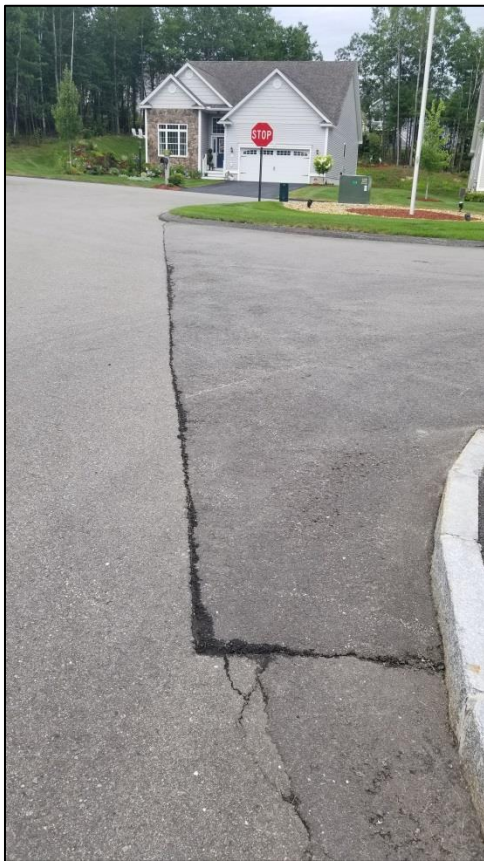
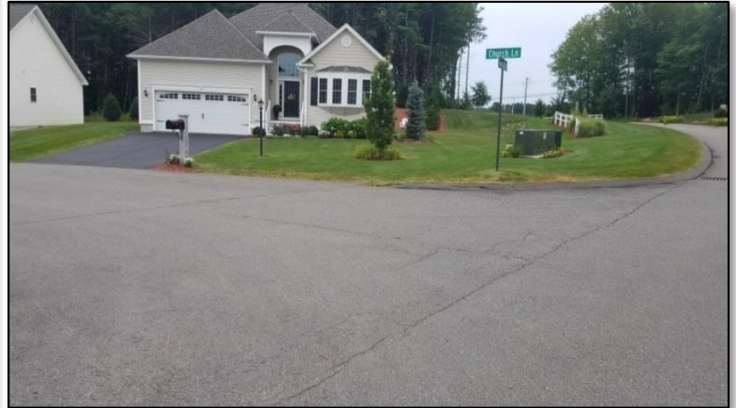
There are also cracks at the intersection of Tavern Hill/Church Lane, and the Community Center driveway that should be filled

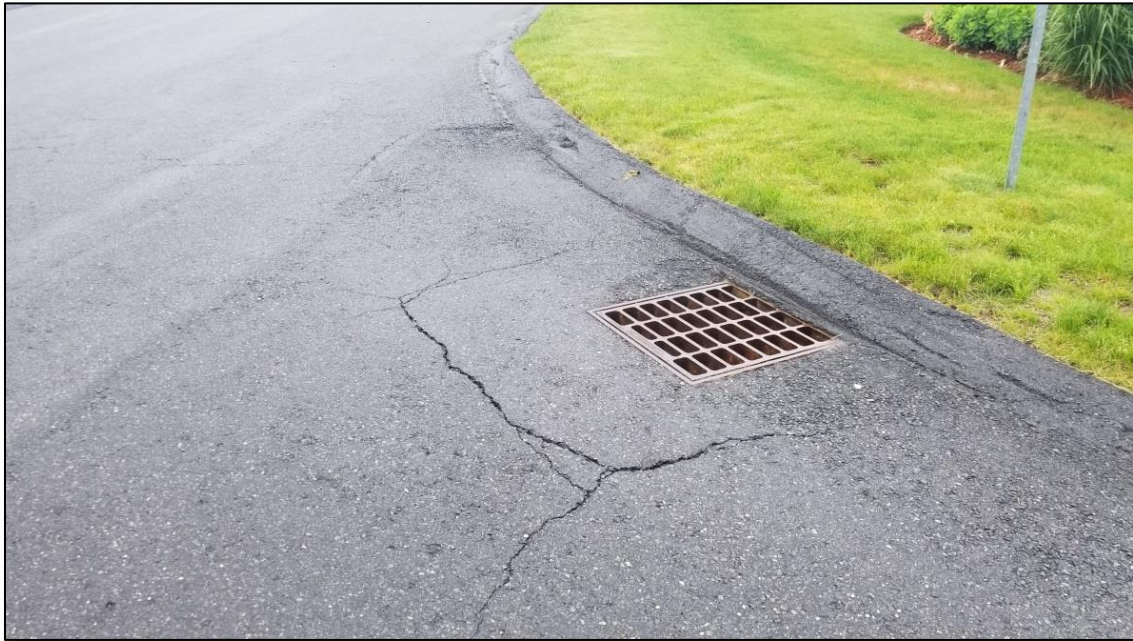
**18. Cracking around catch basin**

One catch basins at the intersection of Tavern Hill and Black Forest have received more cracking than would be considered normal. At a minimum these cracks should be crack sealed to prevent further damage and potholes.

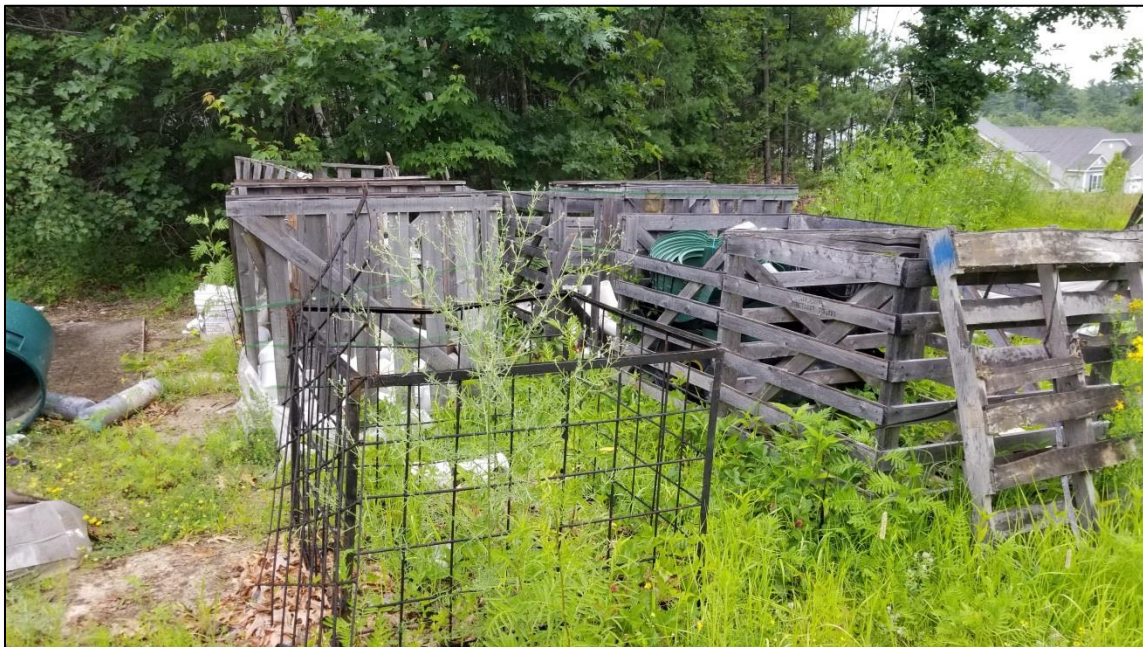
**19. Building Materials**

There are piles of building materials near the cell phone tower. These should be removed.

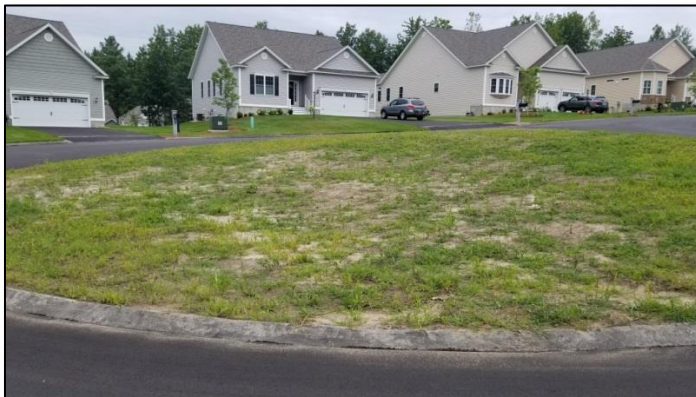
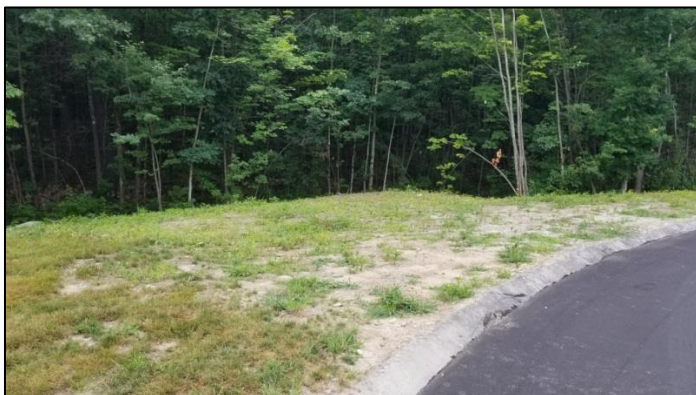
The center of the cul de sac on Pepper Hill Road and the south side of the cul-de-sac have not been stabilized and are in need of loam and seed.

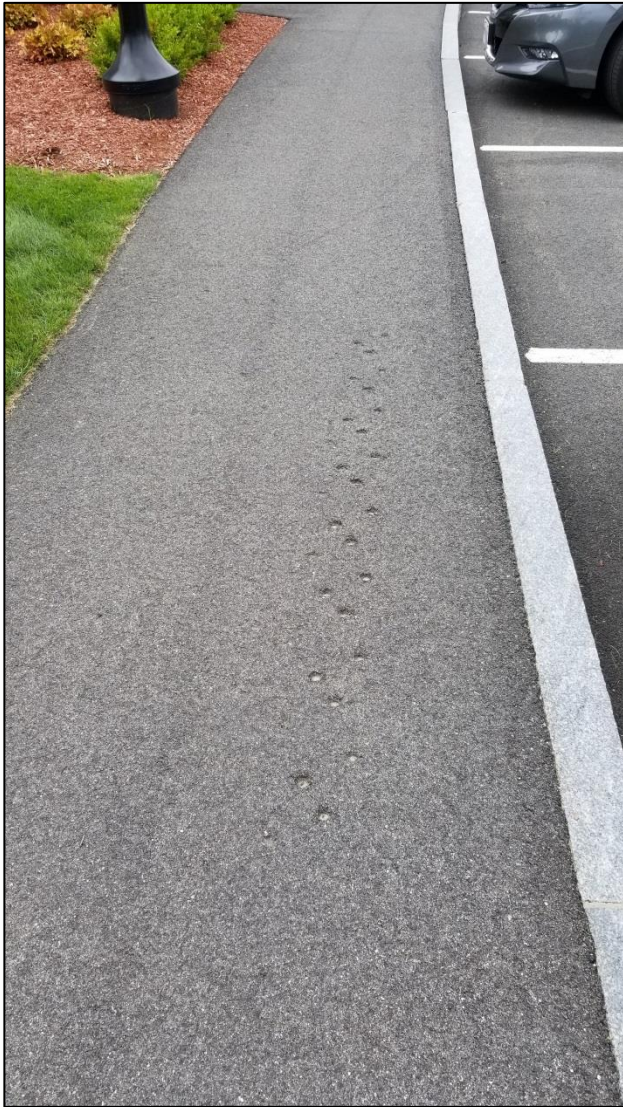
**23. Minor Pitting at Clubhouse Sidewalk**

Some minor pitting was observed in the sidewalk in front of the clubhouse.

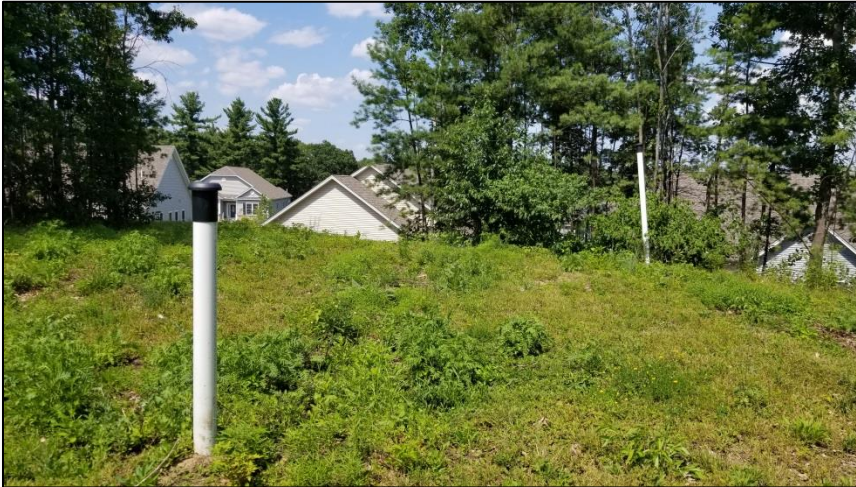
## 24. Septic behind unit 32

The septic vents for the septic system behind unit 32 were installed improperly. The plans (and proper practice) require that a high vent and a low vent be installed. The high vent should be 13' tall and the low vent should be 3' tall. The vents installed in the field are approximately 5' tall and 8' tall. This separation doesn't allow for proper airflow through the system and may cause the system to become anaerobic and fail. The proper venting should be installed.

- High and low vent openings must be separated by a minimum of 10 vertical feet.
- The high and low vents should be of the same capacity.
- A low vent is installed through an offset adapter at the end of each row, Section or Basic Serial Bed.
- Low vents should be a minimum of 3 ft. high or above snow line.
- Alternatively, the low vent may be attached to the d-box and the high vent may be attached to the end of the last AES or Enviro-Septic® row. If this configuration is used in cold climates, the d-box must be insulated to prevent it from freezing.
- A high vent is installed through an unused d-box outlet (see diagram below).
- Sch. 40 PVC or equivalent should be used for all high vents.
- All high vents should be at least 4 in. in diameter.
- All vents higher than 3' should be anchored.

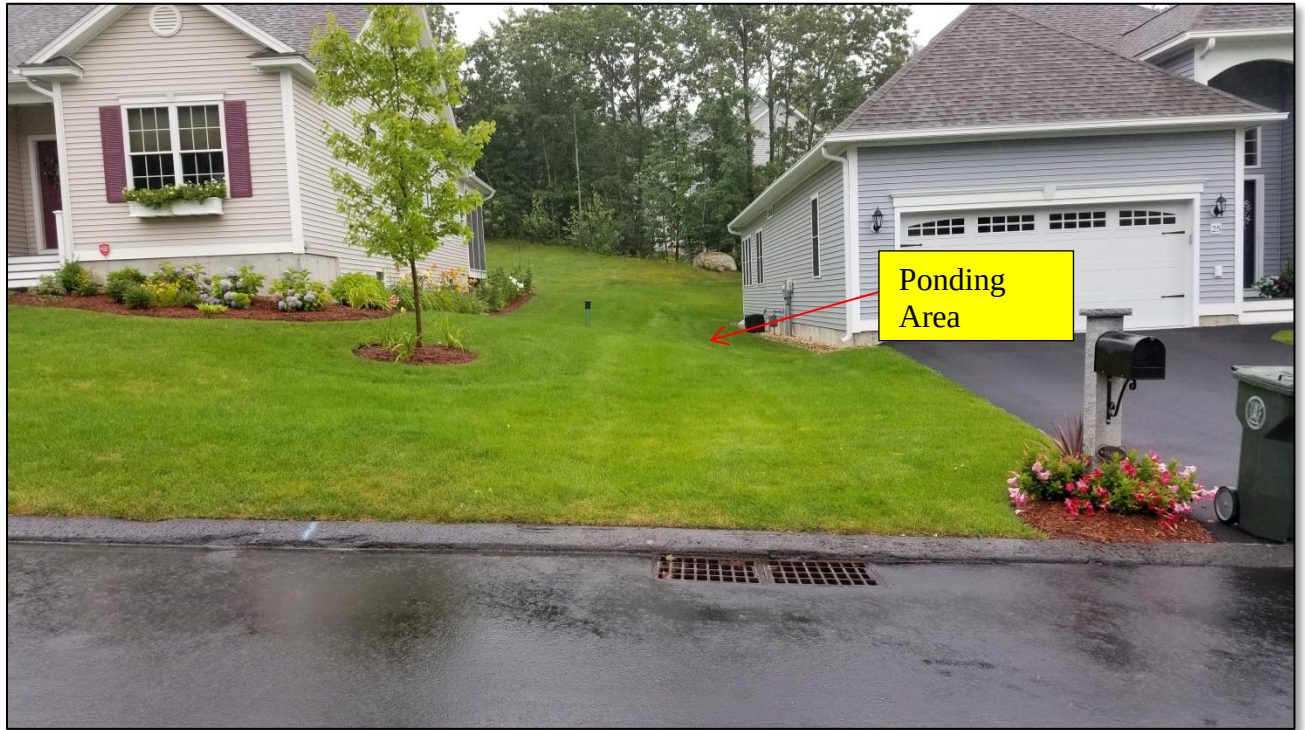
25 Quarry Road has had flooding issues with water ponding adjacent to their home and then seeping into their windows, which required a pump to remove the water. There is a fairly large area behind multiple homes which flows to this area. There is almost no pitch away from the house, and then a high point near the front of the house which retains water. There should be a swale or drain pipe in this area to divert water away from the house. This will continue to be an issue and continue to cause flooding in the basement if not corrected
