# Reserve Study

## Hickory Woods HOA

### Londonderry, NH

September 20, 2018  
Version 3

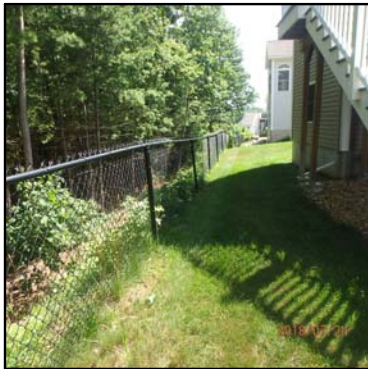
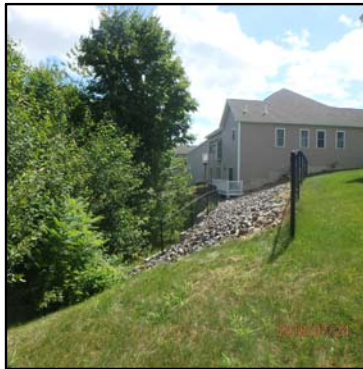
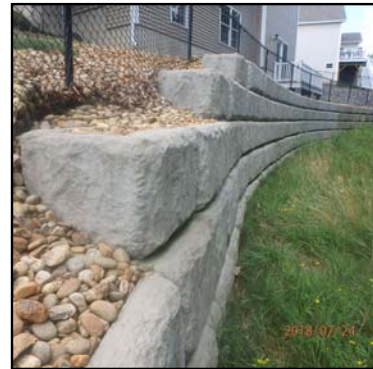
There are 3- to 4-foot-tall chain link fences above the rock-lined slope and associated retaining wall to the north of Pepper Hill Road.

The fencing is in good condition. It will likely need maintenance before replacement. This should be a relatively low cost.

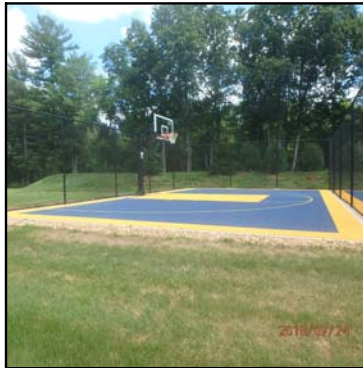
The tennis courts, basketball court, and driving ranges are mostly surrounded by 10-foot high, coated chain link fencing.

The chain link fencing is in good condition.

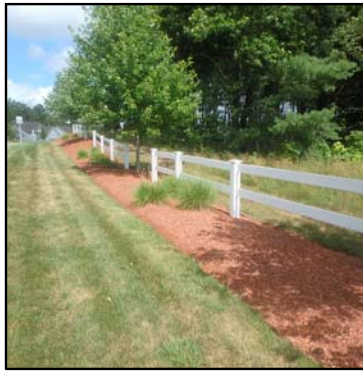
There are eight 20-foot-long white vinyl fences near the entry to the complex, including the fence above the Church Road retaining wall. These are in good condition and relatively maintenance free.

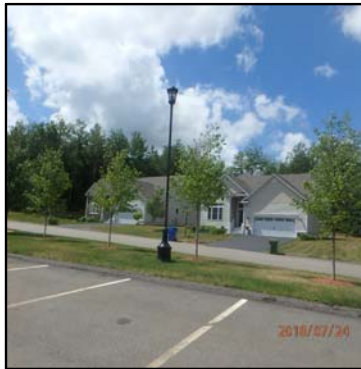
Site lighting is in good condition.

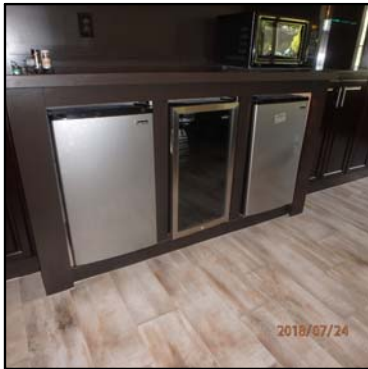
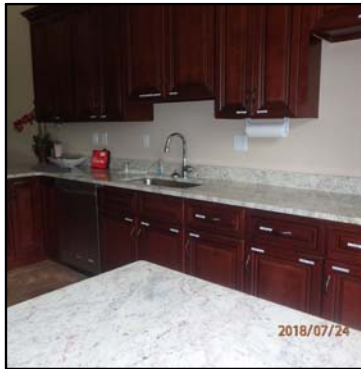
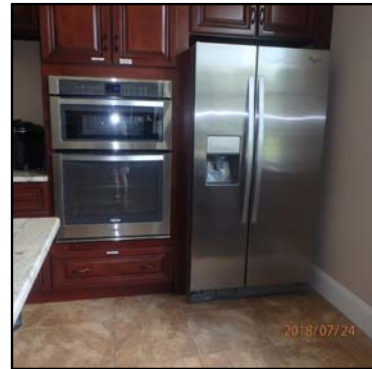
Useful life for the clubhouse appliances assumes low use, with the exception of refrigerators that are operated continually.

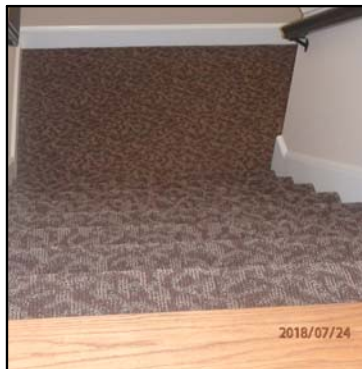
There is carpet in the first floor of the clubhouse. Unit cost assumes replacement with commercial grade carpet.

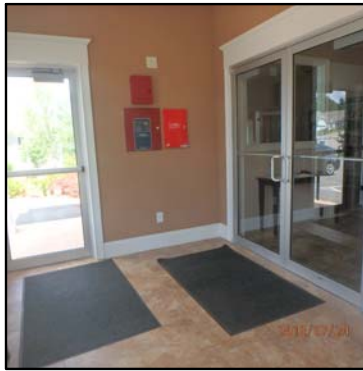
There is 14" ceramic tile in the clubhouse vestibule, hall and kitchen. This component is for replacement of the tile in the vestibule and hall. Replacement of the tile in the kitchen is included with kitchen refurbishing.

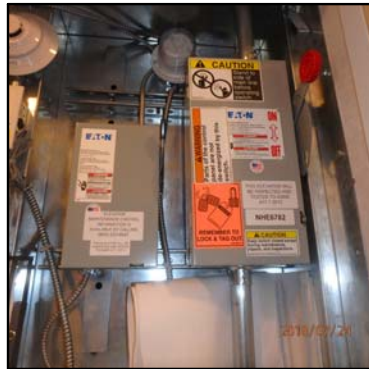
This component is for replacement of machinery and the cab interior, assuming light use.

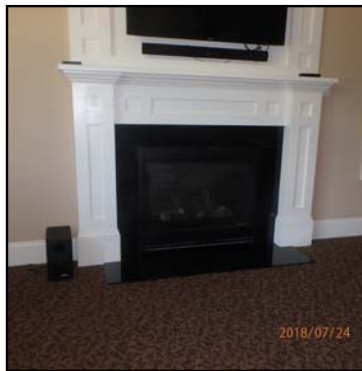
The gas log unit has a fully enclosed metal fire box and a metal chimney, Replacement of the gas log unit and possibly also the chimney should be expected in 25 or more years.

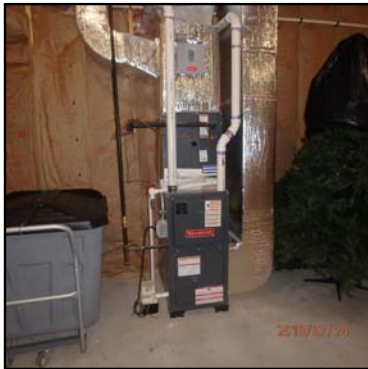
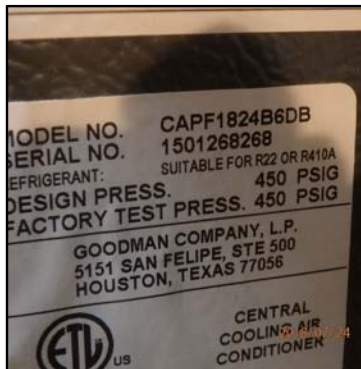
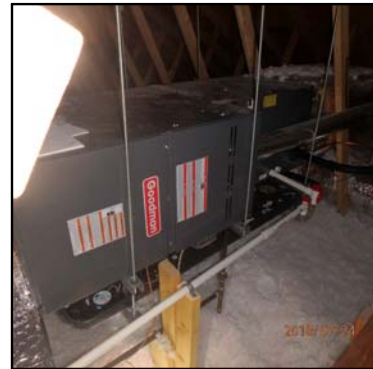
There are 4 Split system natural gas forced hot air systems with Compressor/condensers in the exterior. There are 2 furnaces/air exchanger units in the attic and 2 in the basement.

Attic units have metal chimneys. Basement units have PVC vents for exhaust and supply air.

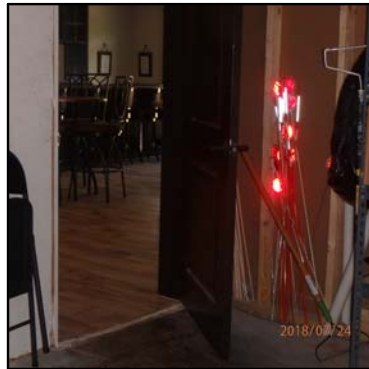
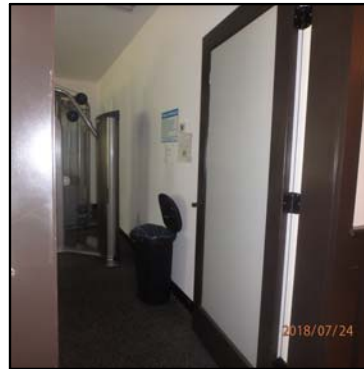
The wood doors in the lower level are of low quality. It cannot be determined whether the glazing is tempered glass. This should be verified. When untempered glass breaks, it can cause serious injury and so should be upgraded as soon as possible.

This component assumes that the glazing is adequate and upgrade of the doors in 10 years.

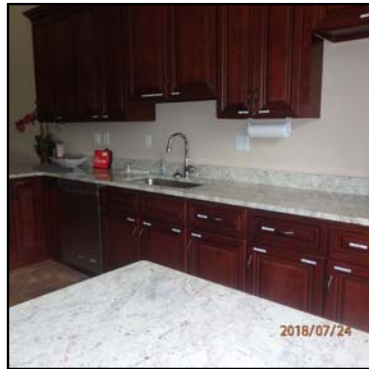
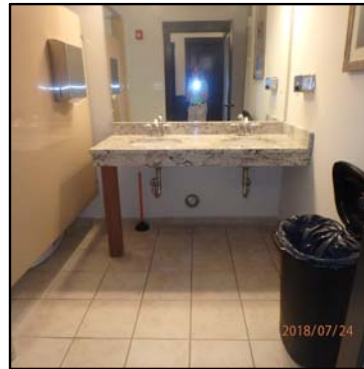
Refurbishing of the kitchen, bar and bathrooms includes upgrades or repair of all surfaces, plumbing fixtures, and electrical distribution. The expected useful life assumes light use.

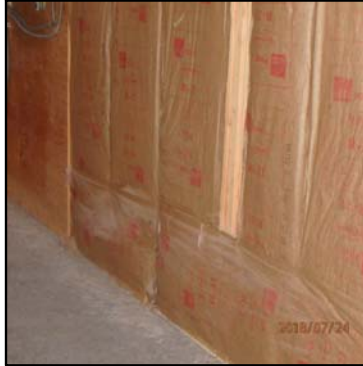
There is fiberglass batt insulation on exterior walls of the lower level mechanical rooms. The paper (a.k.a., Kraft) facing is exposed in the room interiors. This is a fire hazard due to the combustion appliances in the same rooms. The facing should be covered with drywall that is taped and mudded. This should not be a Reserve expense.

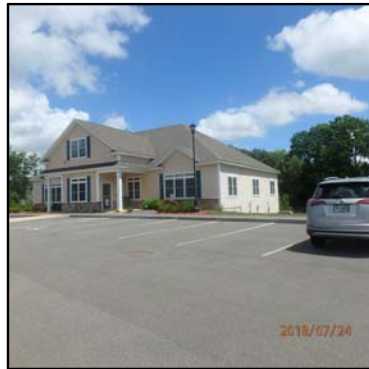
The clubhouse roof surface is architectural shingles, which appear to be in good condition. The shingles appear to be of average quality.

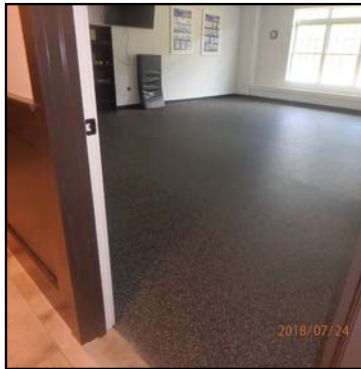
Fitness Room and Gym have a rubberized floor. Use of the flooring is light, but age will deteriorate it without use. Refer to manufacturer's guidance on maintenance and clearing to maximize its life span.

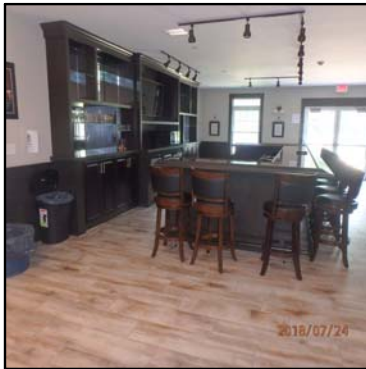
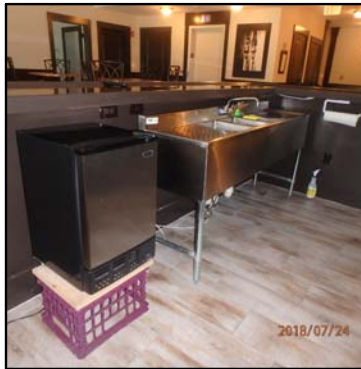
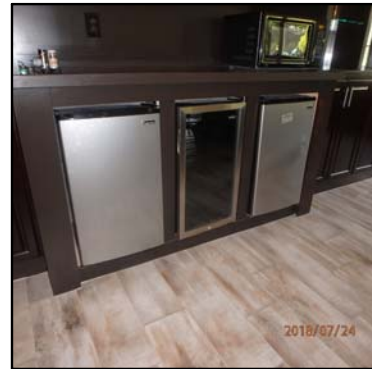
Refurbishing of the bar includes upgrades or repair of surfaces, plumbing fixtures, and electrical distribution. The expected useful life assumes light use.

The quality of tavern finishes, appliances, and plumbing is of lower quality than the kitchen and bathrooms. As such, replacements are anticipated to be sooner.

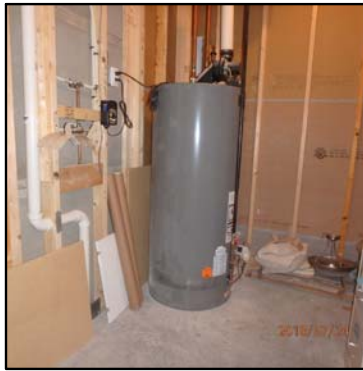
There is a propane fired 75-gallon water heater in the basement.

Upon replacement of this tank, you may wish to install a direct fired unit for the clubhouse to reduce energy loss from a standby tank, and to provide as much hot water as needed on the few occasions when it is needed. The cost provided is for the 75-gallon tank.

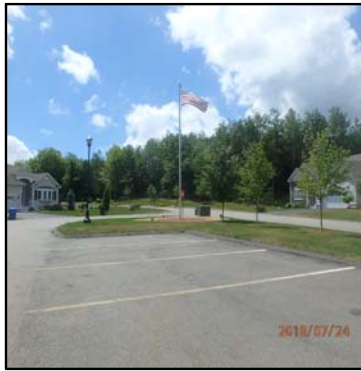
Even the flag pole will need to be replaced eventually.

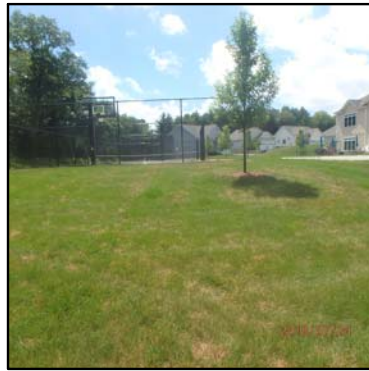
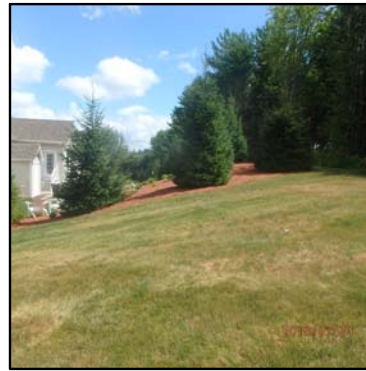
There are trees located throughout the campus that serve aesthetic and shading purposes. Regular care and pruning is considered an operational expense.

Ornamental trees have relatively short life span and require occasional replacement. This component provides funding for long term replacement. Generally, there is a lower cost per tree for younger and evergreen trees.

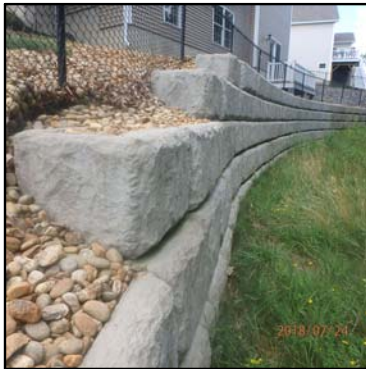
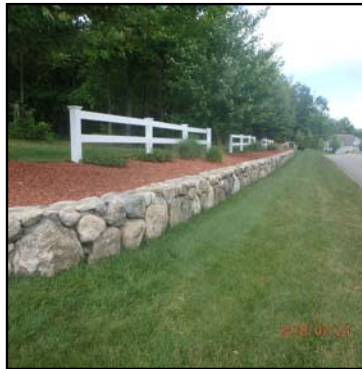
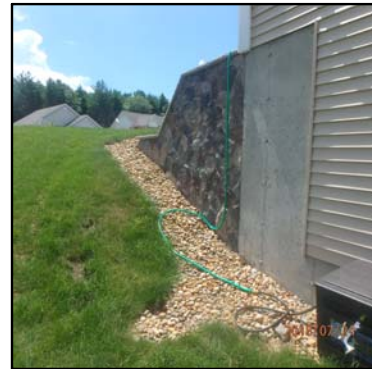
There is an approximate 100 ft.-long interlocking concrete block (ICB) retaining wall behind 14 and 16 Tavern Hill Road. There are up to 5 courses of block. Blocks measure 18" x 24" x 24". There is rock-lined slope above it. Maintenance should include removal of vegetation from the stone on the slope.

The CLD assessment report indicated that there were no engineered plans or permit found for the ICB wall, although its height exceeds 4 ft. While it appears in good condition, there is no guarantee that it will continue to serve its intended purpose for the duration of this study. A ballpark estimate for replacement of the wall is included herein.

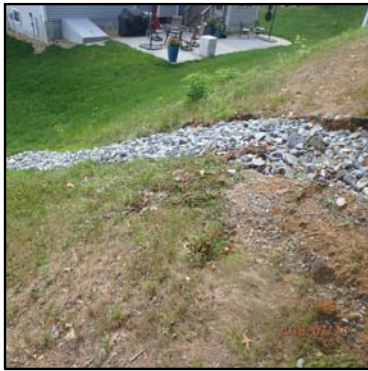
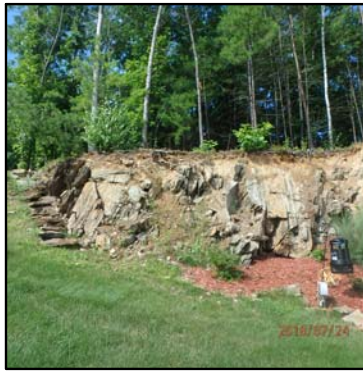
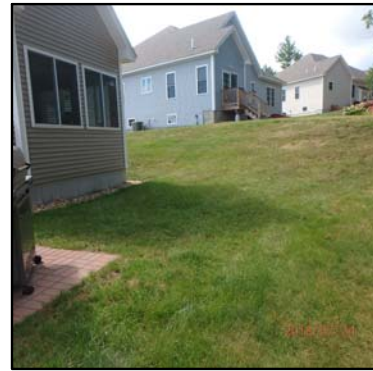
There is flooding occurring behind 29 Black Forest. This can likely be mitigated with the installation of a rock-lined swale that curves around the right rear corner of this building.

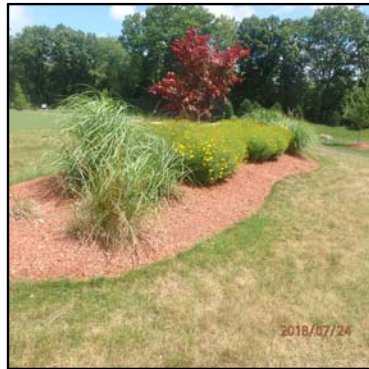
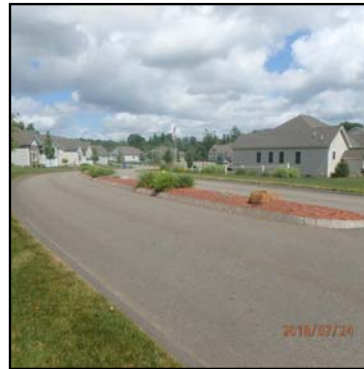
Shrubs have a life span that varies significantly. This component is for replacements of entire planting area. Individual plants that fade or die should be included in operational budget.

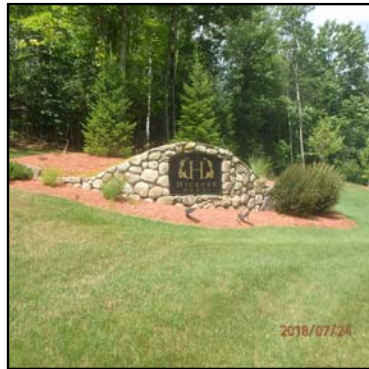
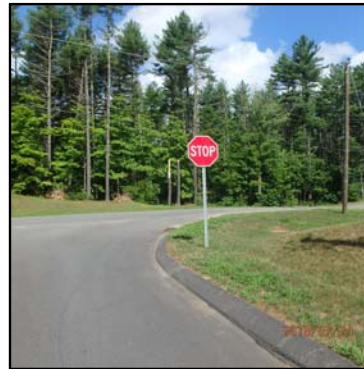
There is the entry sign, which has a stone foundation/back board and lighting. The stone structure is about 40 ft. long and averages about 2 ft. high. This component cost assumes that only the entry wood sign & its lighting will need to be replaced within 20 years, and not the stone foundation and back board.

There are also about 17 stick signs, including road signs, stopping signs, and handicap spaces.

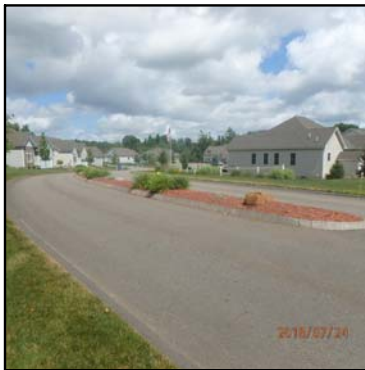
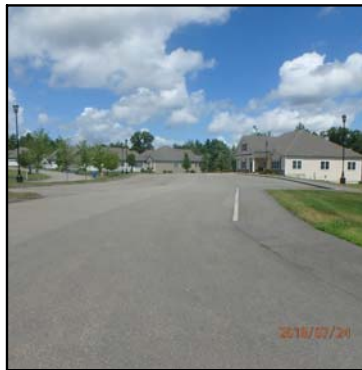
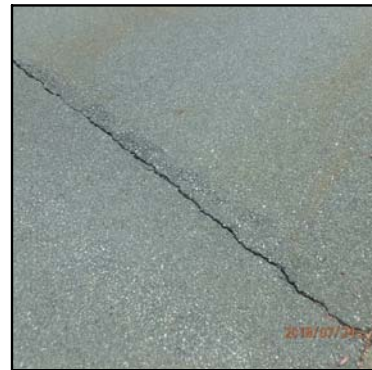
Tavern Hil Road and Church Lane (appox. total of 1,350 sf) were constructed in the 1st phase and were driven over by heavy equipment. The typical width of roadway is 28 ft. CLD reported cracking, which is repaired by the contractor.

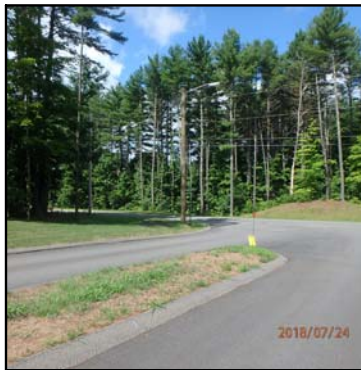
Black Forest Circle, Pepper Hill, and Quarry Road (approx. total of 4,800lf) have a typical width of 28 ft. This asphalt is in good condition.

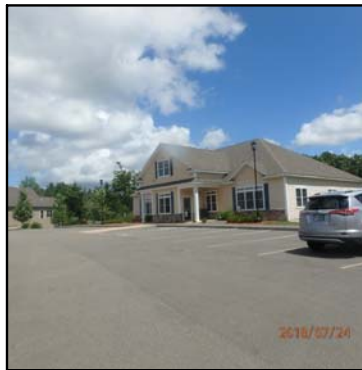
Driveway, sidewalk, and parking area replacement need to be anticipated. Performance of pavement should be assessed during a Pavement Survey and timeframe of replacement adjusted appropriately.

Unit cost assumes a 3" wear course and subgrade compaction. Approx total of asphalt pavement is 80,000 sf. One phase includes 1/2 of the pavement.

- **Paving and Flatwork:** Roadways, Clubhouse sidewalk and parking area are serviceable. The CLD Assessment report highlighted cracking of the pavement. Continued movement and cracking may occur. If it does, this should be addressed in a Reserve Study update. While marred, asphalt "Cape Cod" berms appeared to be performing their intended function for surface water control. These are anticipated to be replaced when a pavement overlay is installed. Settled catchbasins would also be raised at that time.

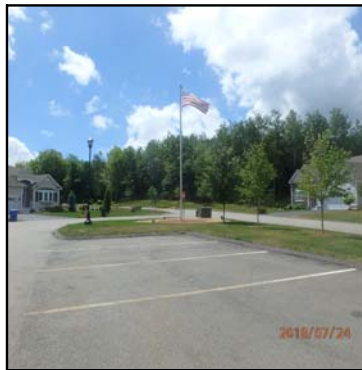
Sealcoating and striping is recommended for asphalt surfaces that do not receive significant wear (i.e., driveways, and clubhouse walkway and parking) in order to extend their surface live. This component is for periodic sealcoat and crack seal applications to all paved asphalt surfaces, to include restriping where needed.

Unit cost assumes the lower cost option of fog seal in most areas. Other seal coat options should be considered after inspection of actual wearing in several years. The extent of full depth cutting and patching should also be revised after inspection of actual pavement performance.

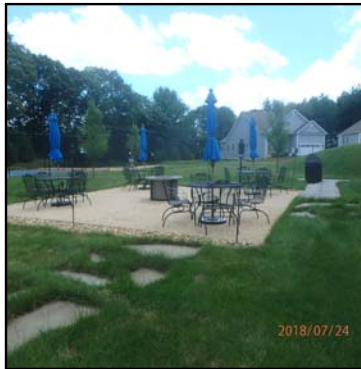
Walkways at unit buildings include flagstone paving materials. The flagstone is generally 2-foot by 3-foot sections. This component is for replacement/restoration of the pavers.

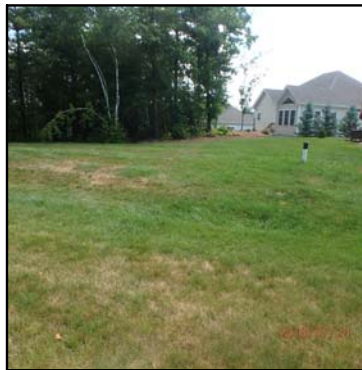
The cost is per unit, because shared leachfields are larger and more costly to replace. Cost information was provided by New Star. The leachfields are summarized as follows:

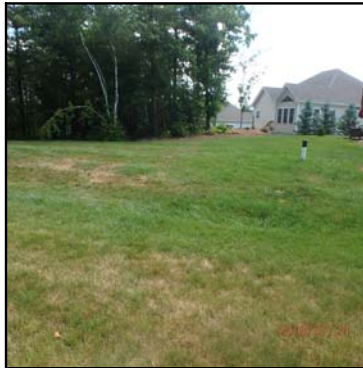
The cost is per unit, because shared leachfields are larger and more costly to replace. Cost information was provided by New Star. The leachfields are summarized as follows:

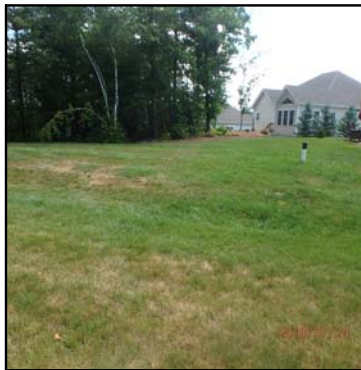
The cost is per unit, because shared leachfields are larger and more costly to replace. Cost information was provided by New Star. The leachfields are summarized as follows:

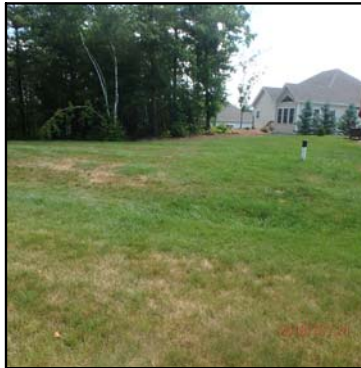
The cost is per unit, because shared leachfields are larger and more costly to replace. Cost information was provided by New Star. The leachfields are summarized as follows:

- 70 private leachfield
- 7 shared leachfields that require pumps
- 2 shared leachfields that do not require pumps
- 1 clubhouse leachfield
- 80 total leachfields

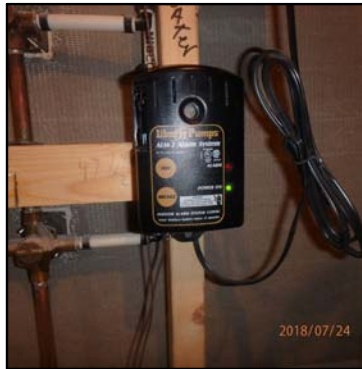
Effluent pumps were not evaluated as part of this Study.

Useful life of effluent pumps is approximately 10 years.

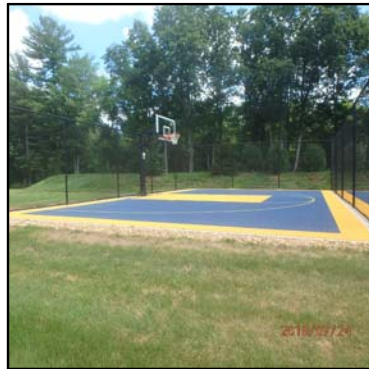
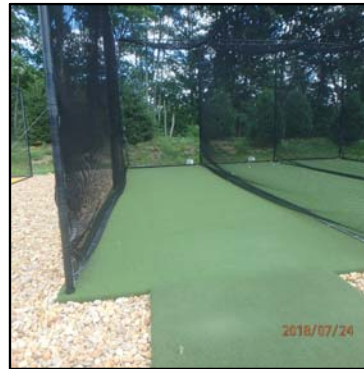
This component is for replacement of basketball hoop pole and backboard, tennis court net poles; repair/replacement of horse shoe court and putting greens; and replacement of the synthetic mats on the courts and artificial turf. Replacement of nets is not included.

The longevity of these amenities depends on maintenance. We advise that you obtain and follow manufacturer's maintenance guidelines for these items, particularly the synthetic mat and artificial turf.

- **Recreational Exterior Amenities:** The grounds to the rear and right side of the Clubhouse have tennis and basket ballcourts with a surface of a specialty synthetic/plastic mesh on concrete mat. The driving cages, golfing green, and bocce courts have synthetic turf. These are high end facilities that are in excellent condition. Manufacturer's information on the plastic mesh and turf should include maintenance guidelines. Replacements will be pricey. Note that there is cracking of the concrete mat under poles for the tennis court nets. These cracks should be repaired soon.

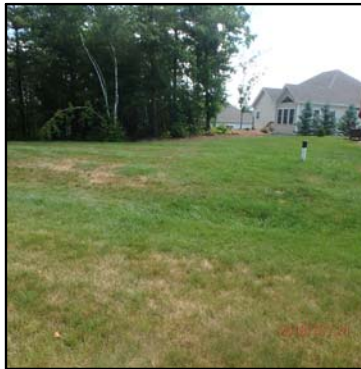
The cost is per leachfield. Information provided by New Star indicates that the cost per leachfield does not increase for shared leachfields. The number of leachfields was determined as follows:

- 70 private leachfield
- 7 shared leachfields that require pumps
- 2 shared leachfields that do not require pumps
- 1 clubhouse leachfield
